**CRASH INJURY INVESTIGATION**

**HU-1A BELL IROQUOIS HELICOPTER ACCIDENT**

Fort Carson, Colorado • 7 May 1962

Report of Crash Injury Investigation  
AvCIR 62-14

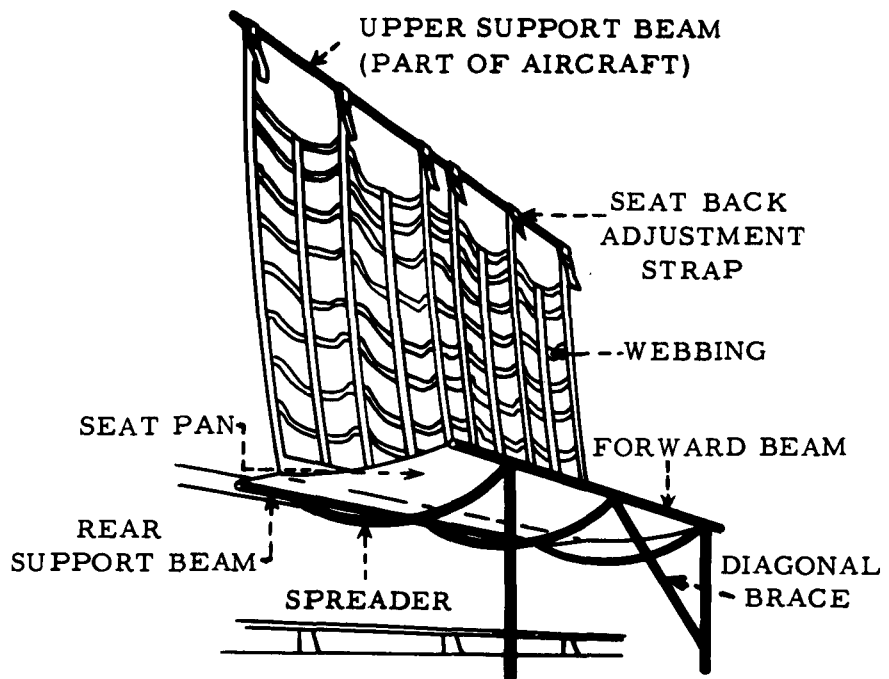
Figure 10. Typical Troop Seat Design.

The standard military troop seats in the HU-1A are designed to MIL-S-5804B. The seat frame consists of upper, rear, and front support tubes to which are attached the nylon seat back and seat pan. The seat legs are attached to the front support tube. Curved spreaders maintain the distance between the front and rear support tubes. Figure 10 illustrates the design. The upper support tube was the only portion of the troop-seat structure which failed in this accident. The failure probably occurred when the upper portion of the aft bulkhead, to which the upper support tube is attached, folded rearward during the roll portion of the accident sequence. The extreme left seat leg was "popped" loose from its floor anchorage. The floor anchorage, together with a small section of the floor, was pulled down by structure beneath the floor. Apparently this occurred when the fuselage struck the ground during the initial portion of the crash sequence. Figure 11 shows the floor and anchorage. All the seat legs and seat pan hardware remained intact. The passengers' seat belts showed no damage except for being cut by rescue personnel.

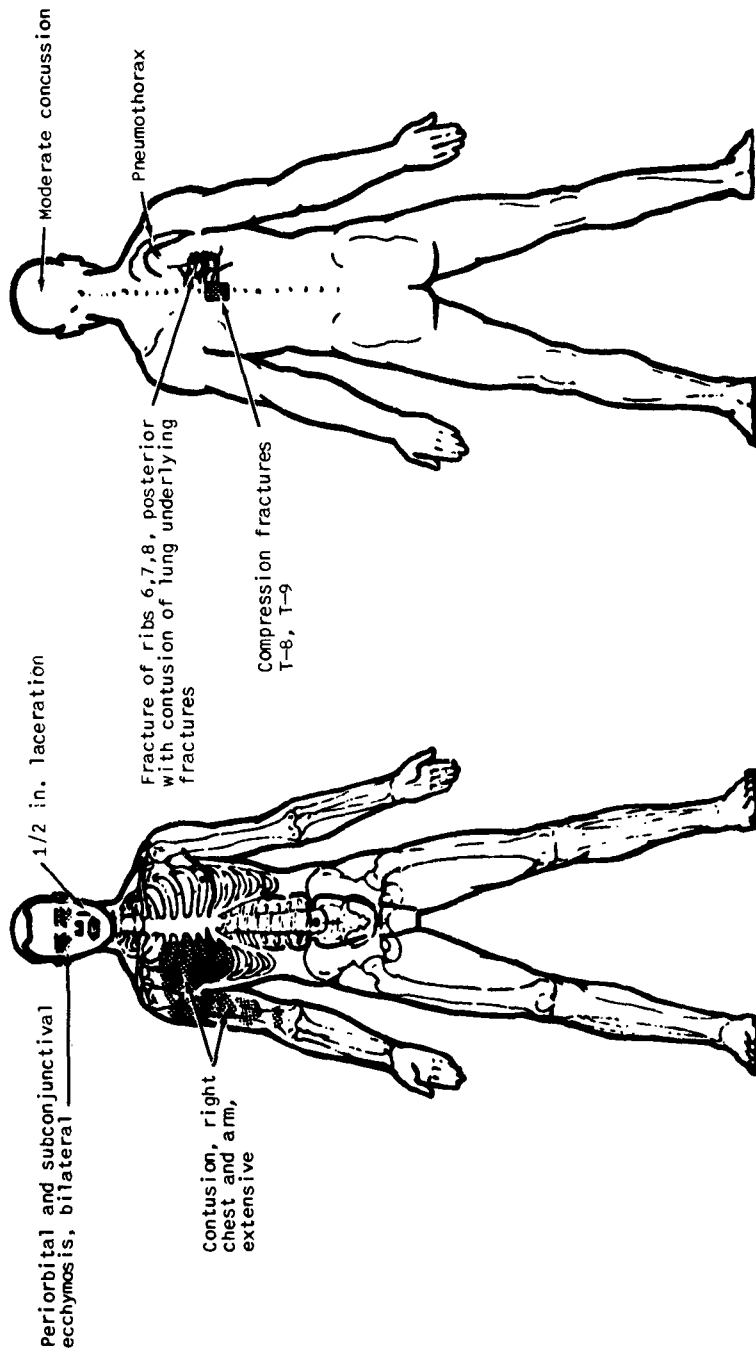
PILOT - RIGHT SEAT  
 HU-1A ACCIDENT, FORT CARSON, COLORADO  
 7 MAY 1962

The occupants of the pilot and copilot seats both suffered injuries as a result of the collapsing roof when the aircraft rolled over. They both were secured in their seats by lap belts and shoulder harness. When the roof collapsed, they were compressed in their seats, resulting in the compression fractures of the pilot's T7, 8, and the copilot's T8, 9 thoracic vertebrae, as well as in the pilot's concussion, and in the contusions and lacerations of both of their heads and upper torsos. The pilot's head was protected by an APH-5 helmet, which prevented more severe injury (discussed separately under protective gear).

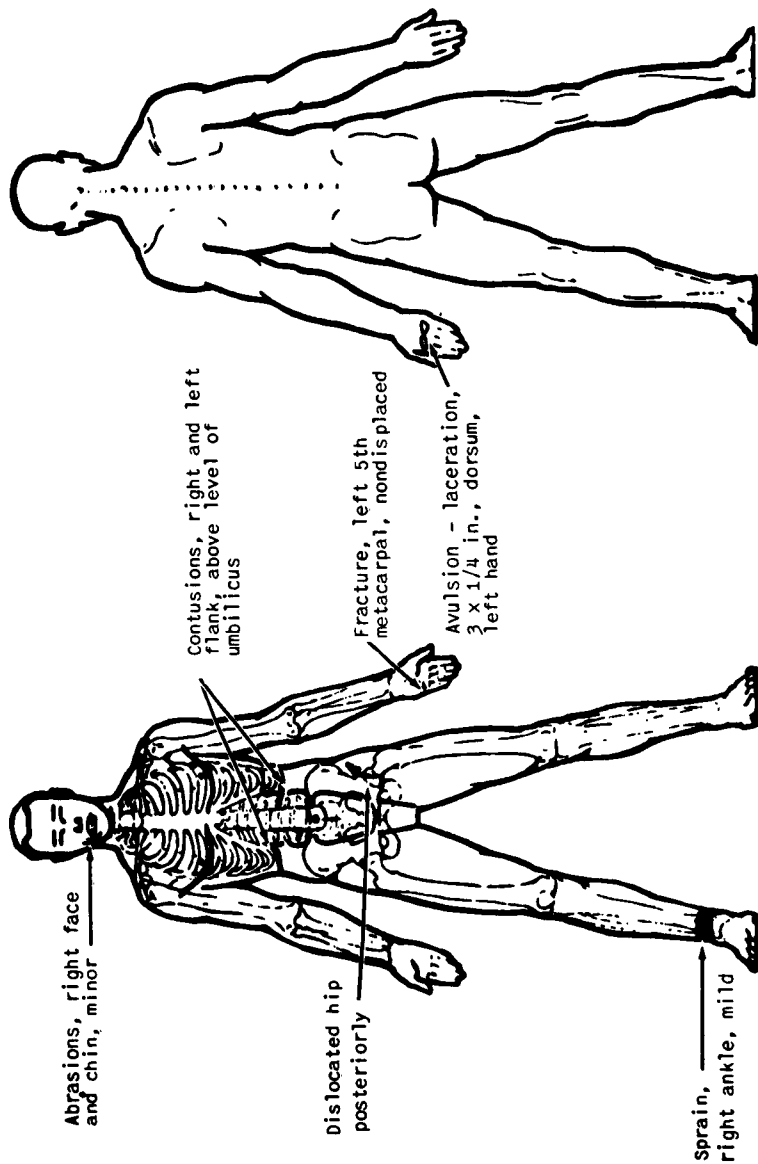
PASSENGER - TROOP SEAT L-1  
 HU-1A ACCIDENT, FORT CARSON, COLORADO

Passenger L-1 suffered an injury to his left hip which cannot be attributed to any of the usual categories of crash injury. When this passenger realized that a crash was imminent, he prepared himself by bracing himself in his seat. One of the bracing gestures he used was to plant his left heel firmly against the air vents at the bottom of the forward cargo compartment side wall. This placed his leg in an internally rotated position. He then flexed forward with his chest on his thighs. This position allowed for easy posterior dislocation of the femoral head out of the acetabulum without other injury to the pelvis or femur, when he was accelerated forward and floorward against the anchored heel.

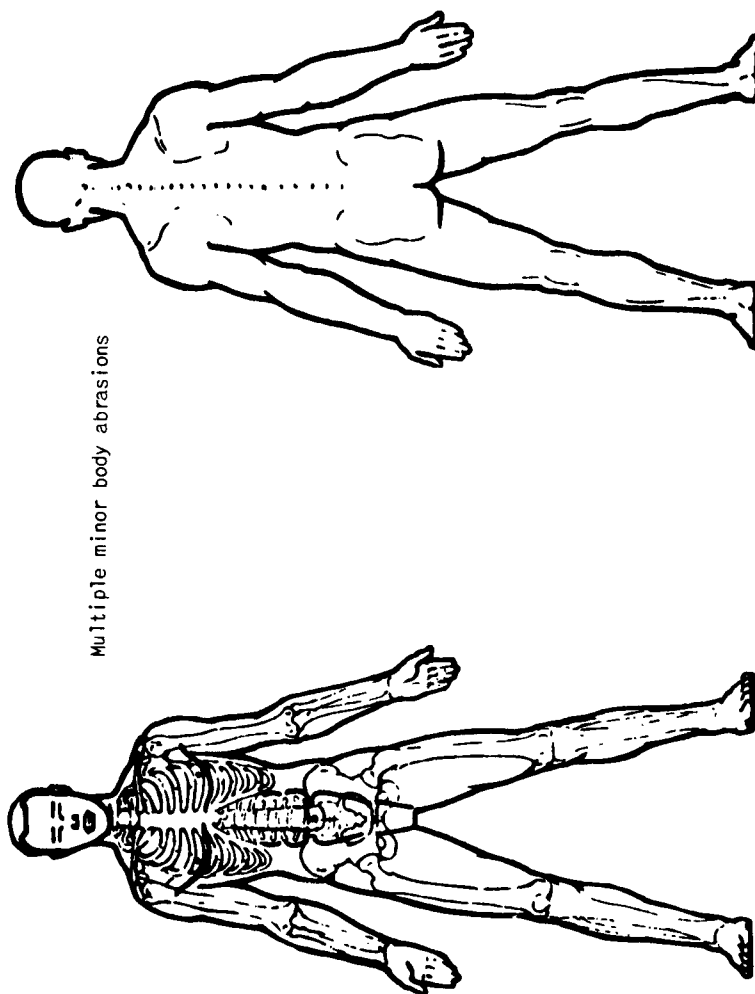
PASSENGER - TROOP SEAT L-2  
HU-1A ACCIDENT, FORT CARSON, COLORADO  
7 MAY 1962

Multiple minor body abrasions

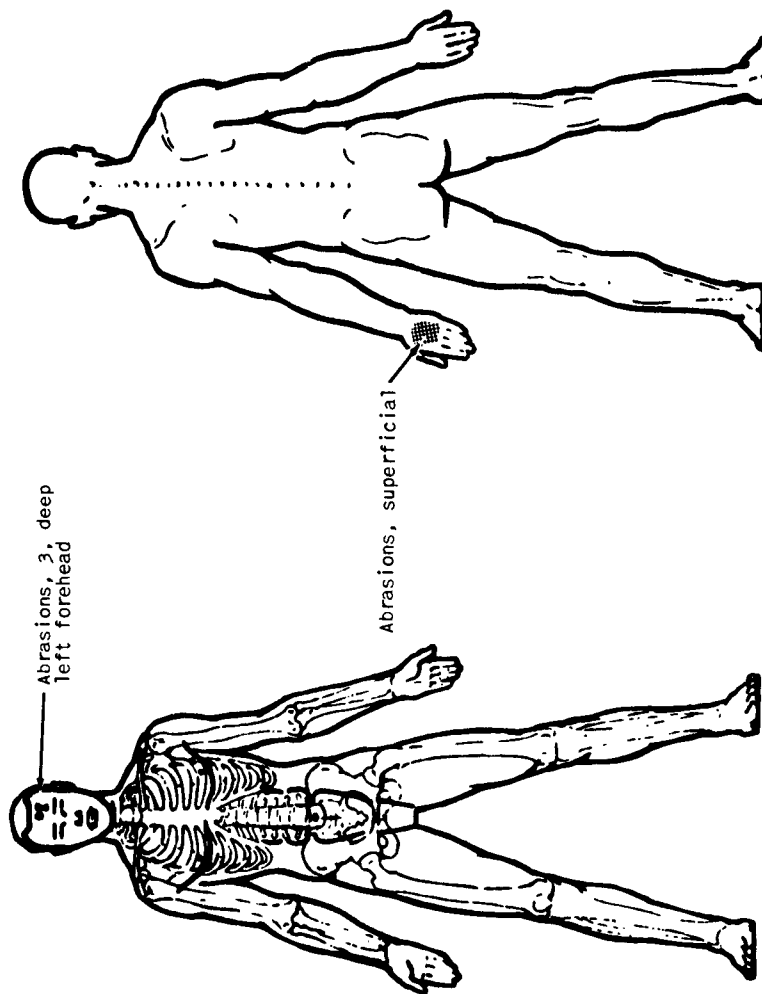
PASSENGER - TROOP SEAT R-1  
 HU-1A ACCIDENT, FORT CARSON, COLORADO  
 7 MAY 1962

The injurious environment in this accident developed as a result of the failures listed above, and thus cannot be described with any degree of finality. The contusion to R-1's forehead could have occurred as a result of his flexing forward and contacting the back of the pilot's seat or other environmental structure. The possibility also exists that the lack of lateral restraint, after the door popped off, left him with no protection from the outside when the aircraft rolled over.

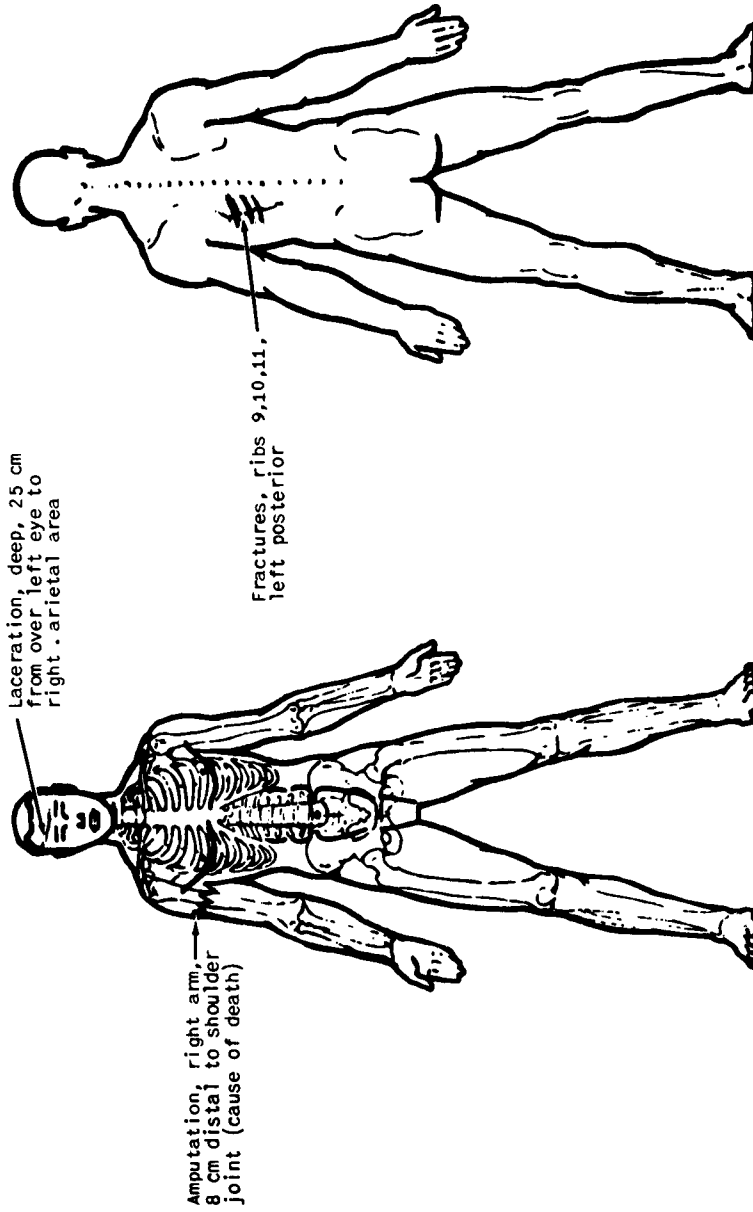
PASSENGER - TROOP SEAT R-2  
 HU-1A ACCIDENT, FORT CARSON, COLORADO  
 7 MAY 1962

The fact that the doors of the HU-1A came off probably was a factor in the amputation of passenger R-2's right arm. The removal of the doors is not considered an overall detrimental feature, as in the majority of accident cases this feature expedites passenger evacuation. His arm was cleaved off as the aircraft made its first roll to the right, and it was found intact in the immediate area of the aft portion of the right skid. It is not possible to determine exactly how his arm was amputated, but as the craft rolled to the right and the door popped off, his arm was thrown out of the right doorway, either because he was bracing himself against this door, or due to inertial forces. His arm was then cleaved off cleanly 8cm distal to the shoulder joint by being forced against the outboard edge of the firewall, as is evidenced by the presence of residual tissue in this area. Whether it was cleaved off by the door or the right skid is not apparent by examination of these items; the amputated arm showed no pertinent evidence to the examining pathologist. The sleeve and arm were entirely intact, showing no evidence of being abraded off by the ground. Death followed by exsanguination.
